## MIAMI BRIDGE WEEKLY NEWSLETTER

242 Days are  
Remaining on the  
Bridge Closure

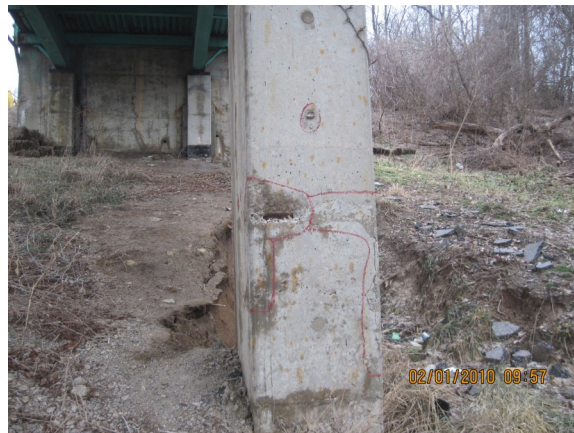
Deterioration at Bent 2, West Column

**Bent 2**—It was decided that it will be more economical to remove and replace both columns at this bent down to the construction joint above the existing sway bracing. This decision was due to the estimated quantities of sub-structure repair being more than what was called out in the plans.

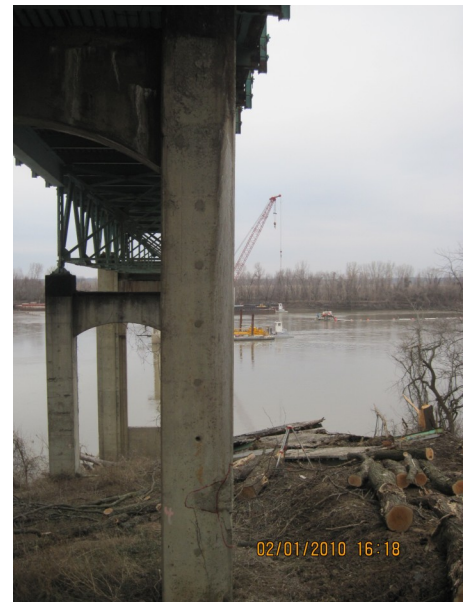
Deterioration at Bent 2, East Column
